<b>Printronix Technical Bulletin</b>	Number 5-0039	Revision A
	Product Type P5000	Date 05/01
<b>Subject</b> Identifying and Troubleshooting CMX Component Areas	Originator Gary Gentry	Page 1 of 18

**IDENTIFYING CMX COMPONENT AREAS FOR P5000**

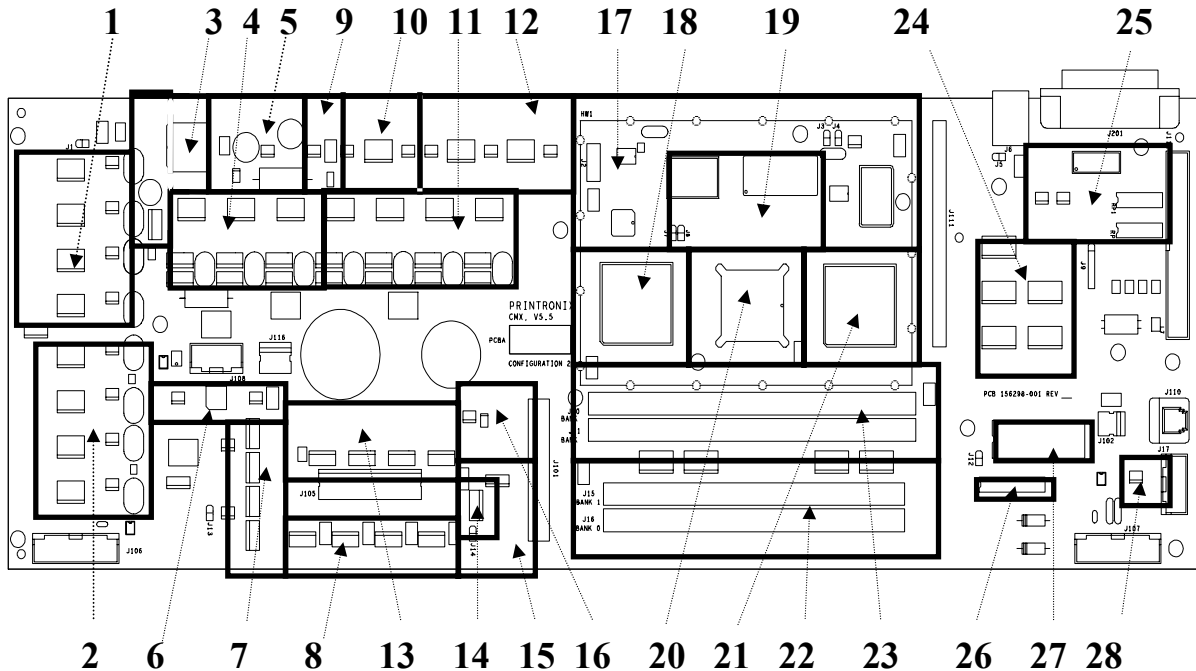
### CMX Component Area Information Diagram

The diagram on the next page is the layout of the main logic and power areas of the CMX. Use it to help isolate problems when there is no control panel display or when the printer boot sequence has been interrupted by an internal error.

This diagram is an aid for doing visual inspection on the following 2 CMX PCBAs:

Find the area of interest and note the number pointing to that area. The number describes that area below the diagram. The following pages list those areas found on the diagram in numerical order. Beside each number the following are listed:

The main components for that area, the possible error messages, the definition of the area and the recommended troubleshooting that may help isolate the root cause of the failure.
