## 5–10. Platen Gap (Figure 5–8)

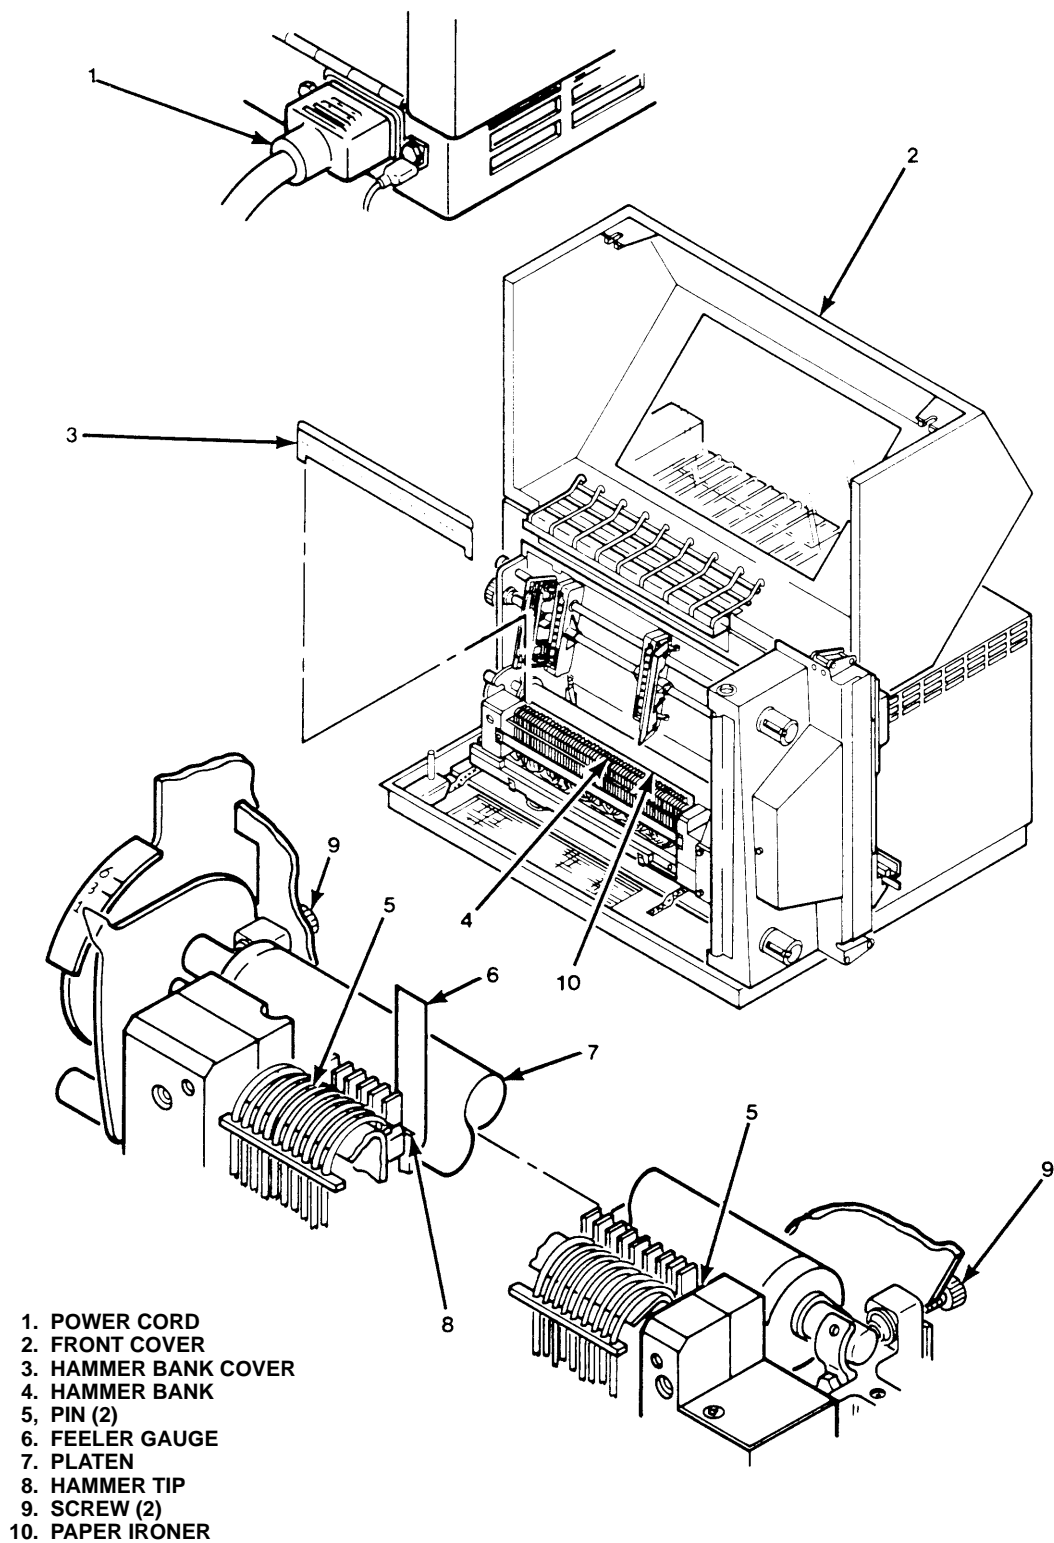
Figure 5-8. Platen Gap Adjustment

- (a) With Forms Thickness Lever open, insert flat feeler gauge (6) between platen (7) and hammer bank cover (3) within six hammer positions of left end of hammer bank. Use 0.012 inch feeler gauge for P300 and non–phase fire P600; Use 0.010 inch feeler gauge for phase fire P600. (Non–phase fire P600 printers do not have heat sinks on the shuttle coils.)

- (b) Carefully lower Forms Thickness Lever until platen (7) just contacts feeler gauge (6) with lever fully closed. Gauge should move with only slight friction. Make sure gauge is vertical and in the same plane as (flat and in front of) hammer tips (8). If out of adjustment, see step 6.

5. Repeat step 4 for right end of hammer bank.
6. If platen gap is incorrect:
  - (a) Adjust two support screws (9) as required. Note that 1/4 turn equals about 0.007 inch. Remember that adjusting one end affects the other end. Therefore, if one end is off by more than 0.001 inch, it should be only partially adjusted before checking and adjusting the other side.

1. Disconnect power cord (1). Open front cover (2).
2. Raise Forms Thickness Lever to the open position.
3. Remove paper and ribbon from printer.
  - a. If the user reports that some characters are not printing, or if you find any other symptoms that indicate the hammer bank cover (3) is misaligned, proceed to substep 3.b.; otherwise, continue at step 4.
  - b. Check that the hammer bank cover (3) is positioned correctly: it must be flat on the hammer bank with the holes aligned with the hammer tips and properly seated on the roll pins (5) at both ends. If accessing the hammer bank is required to check this, perform the steps in paragraph 3–4c.
